# Crosby/Bullard Golden Gate® Hook Assembly Inspection Criteria

AERO-MOTIVE COMPANY

**NOTE:** Procedure applies to all JA, KA, and LA series balancers with upper Bullard Hook option.

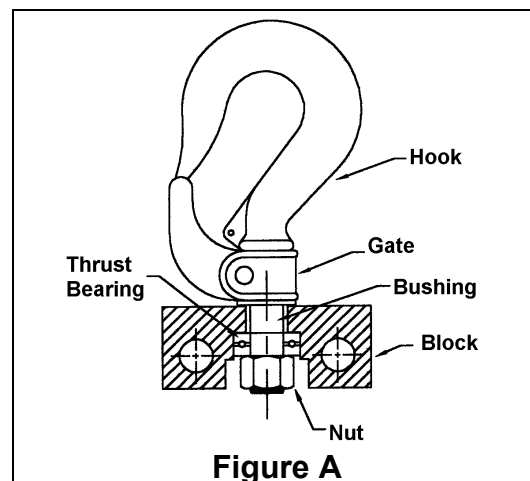
Figure A

While the balancer is hanging by the bullard hook, align the hook with the mounting block to create a uniform space between the gate and mounting block. (see Figure A)

It is not necessary to add or remove load to/from the balancer unless it interferes with the orientation of the hook with the block.

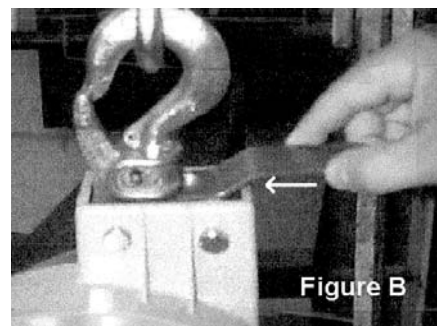
Figure B

If the feeler gauge does not easily slide between the bottom of the gate and the block, then hook passes the initial screening and does not require further evaluation. (see Figure B)

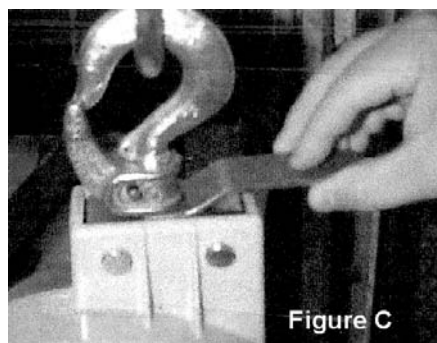
Figure C

If the feeler gauge (Part# M92000001) slides under the gate such that the slot straddles and completely seats against the bronze bushing flange, then the system should be considered suspect. (see Figure C)

**NOTE:** Suspect systems do not necessarily need to be replaced. Proceed to secondary evaluation step to determine if replacement is necessary. If hook passes the 2<sup>nd</sup> review, then monitor hook on a more frequent basis.

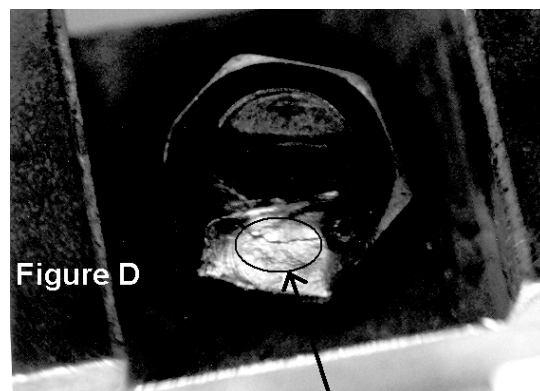
Figure D

The weld is solely intended to keep the nut from unscrewing during the twisting and turning motion of normal operation. This motion can, in some extreme cases, cause the weld to fatigue. The evidence of a fatigued weld is a cracking along any part of the weld (see Figure D). Use of a dye penetrant is recommended. Any evidence of a fatigued weld should result in replacement of the system. Any indication that (a) the weld has separated from any section of the nut or the shaft or (b) the nut has rotated relative to the shaft is also cause for replacement.

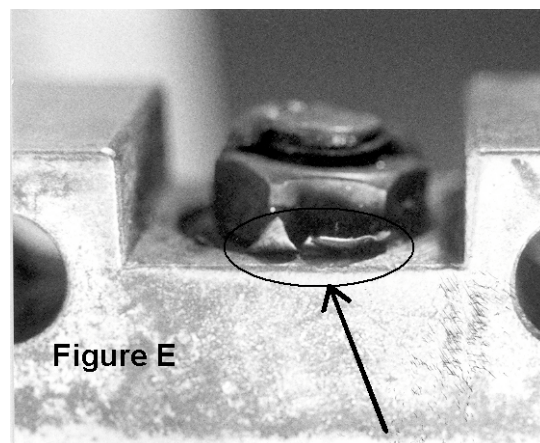
Figure E

Extreme wear or failure of the thrust bearing will ultimately cause a system failure. As the bearing ceases to perform normally, the nut will turn relative to the bearing case causing case deterioration, shank fretage and/or nut fretage. (see Figure E). Any evidence of extreme thrust bearing wear or failure should result in system replacement. Prior to reassembly, free rotation of the bearing (when the assembly is in its normal position - hook up) should be confirmed. Evidence of binding or impeded rotation is a likely precursor to failure. Consequently, in this situation the complete hook assembly should be replaced.

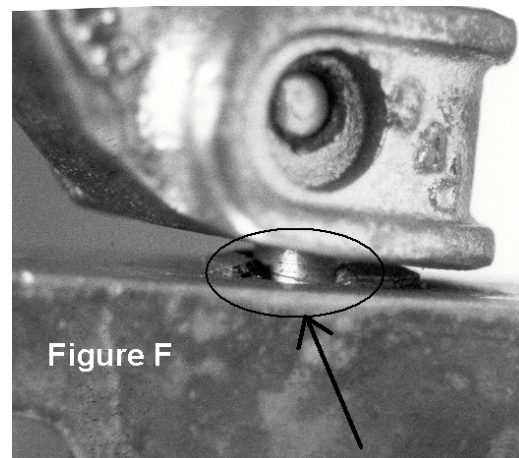
Figure F

If the cylindrical section (sleeve) of the bushing has worn significantly, the shaft and gate will tilt relative to the bushing under the twisting and turning motion of normal operation. This, in turn, will result in wear of the bushing flange. While the wear of the flange itself is not a direct threat to the operation or safety of the unit, the implication of a worn sleeve is significant. A worn sleeve will result in a non-uniform load on the thrust bearing by the nut. This situation will in turn hasten weld fatigue and/or thrust bearing wear discussed above. Evidence of a flange worn to a thickness of less than 1/32" (0.031) should result in system replacement. (see Figure F)

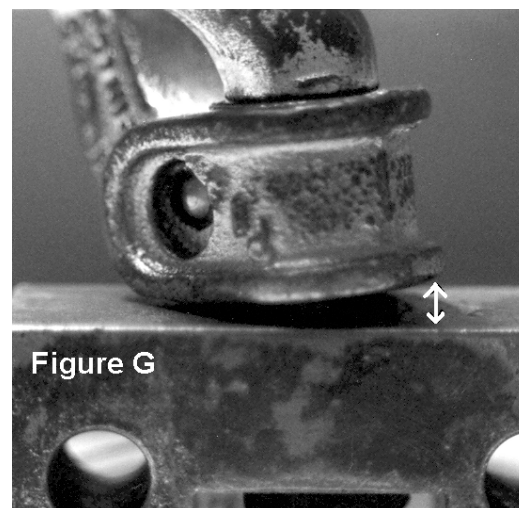
Figure G

The combined effects of slightly worn bushing sleeve, thrust bearing can result in fretting on the nut corners during the twisting and turning motion of normal operation. Any indication of excess axial slack or extreme wear on the corners of the nut should result in system replacement. (see Figure G)
